**D-Link Systems, Inc.™**  
**xStack Storage DSN-3200 & DSN-3400**  
**ECN – Drive Activity Light Fix (rev. 1)**

This document is an ECN (Engineering Change Notice) concerning the identification of affected DSN-3200/3400 units shipped before January 2008 and the installation of four resistor packs to fix the issue.

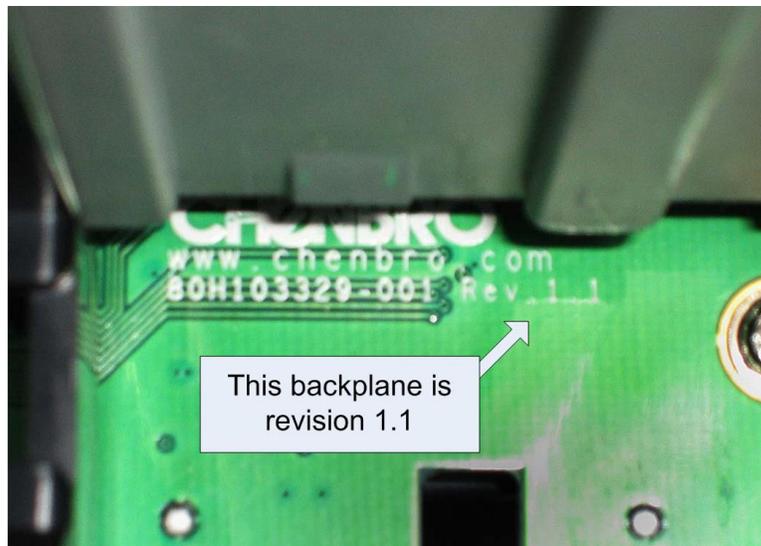
**Figure 2: Identifying the backplane revision number**

Step 4) Using a flashlight, examine the upper portion of the now visible chassis backplane PCB (Printed Circuit Board) located at the rear of the space. You should see something similar to that found in figure 2. Here you will see a revision number. If your backplane has revision 1.4 or later, then your system is up to date and needs no changes. If your system has Revision 1.1, 1.2 or 1.3, then you will need to continue to step 5. You may now reinsert the drive trays.

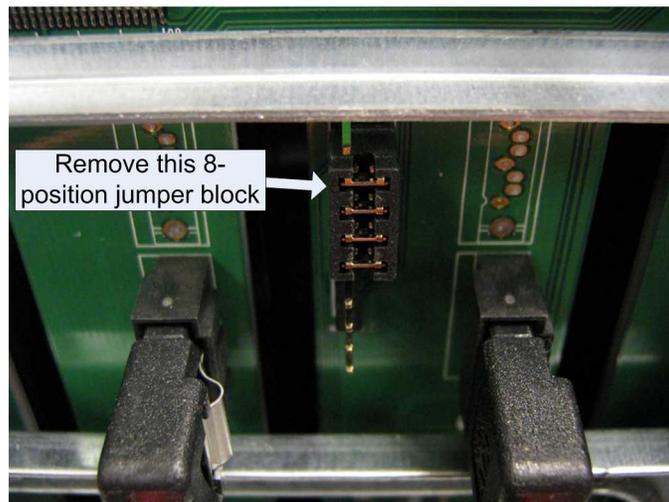
**Figure 6: A jumper block installed on a 10-position jumper**

Step 7) If you see a jumper block installed on each of these four headers like that shown in Figure 6, then you will need to proceed to Section 2 for instructions on installing the new resistor packs. If you see a modified jumper like that found in figure 7, then your system has been modified with the necessary resistor packs. You may close your unit's cover and return to normal operation.

If you have followed the steps outlined in Section 1.3 and determined that you need to install the resistor pack modification, then please contact D-Link or your reseller to obtain the four (4) necessary resistor packs. These resistor packs will take the place of each of the four jumpers found on the four 10-position headers labeled NA1315, NA0912, NA0508 and NA0104.
