**Firmware Version:** 2.51.B007  
**Boot Code Version:** 1.00.015  
**MIB Version:** 2.50.002  
**D-View Module Version:** 1.0.0.7  
**Published:** Aug. 25, 2014

These release notes include important information about D-Link switch firmware revisions. Please verify that these release notes are correct for your switch:

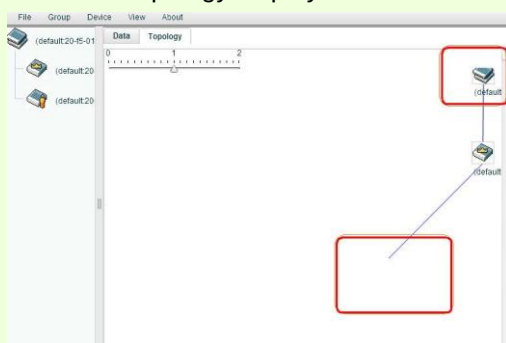
8. Modify default System Time to 01/01/2011.
9. The drop-down fields of Time Profile 1 and 2 always show "None" instead of correct profile name when the profile name is more than 1 character.
10. First create VLAN2 then add port2 to Tag member and change PVID to 2 then add port3 to tag member, we find port2 PVID will change to 1. (We suggest don't change tag port PVID when untag change to tag and keep it by user manual).
11. First change TX Hold Multiplier to 2 then change TX Interval to 32767, then change TX Hold Multiplier to 3 and TX Interval to 120, we find the message "Invalid Message TX Hold Multiplier."
12. We suggest add "clear" button in LLDP Statistics Table.
13. The SIM Topology display error when we move device ICON, please see attach picture.

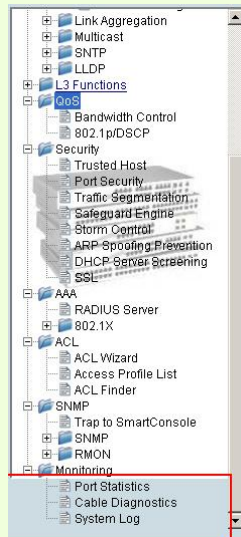
## 14. Web UI displays abnormally in Firefox 5.0 under Fedora 9

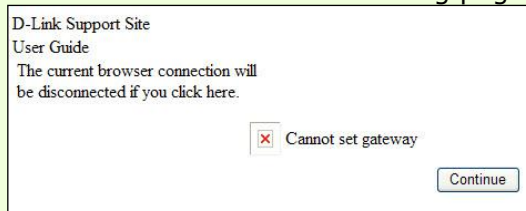
## 17. If apply DUT's IP address as the gateway in Smart Wizard, the web will redirect to the incorrect warning page.
