**Firmware Version:** 2.51.B022  
**Boot Code Version:** 1.00.017  
**MIB Version:** 2.50.002  
**D-View Module Version:** 1.0.0.7  
**Published:** Apr. 09, 2018

These release notes include important information about D-Link switch firmware revisions. Please verify that these release notes are correct for your switch:

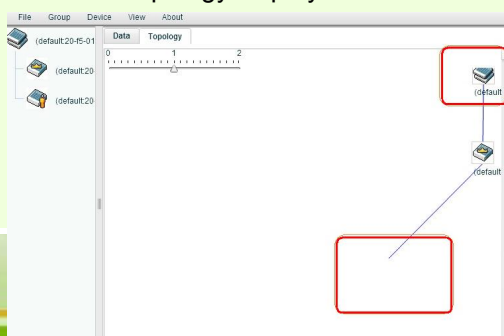
8. Modify default System Time to 01/01/2011.
9. The drop-down fields of Time Profile 1 and 2 always show "None" instead of correct profile name when the profile name is more than 1 character.
10. First create VLAN2 then add port2 to Tag member and change PVID to 2 then add port3 to tag member, we find port2 PVID will change to 1. (We suggest don't change tag port PVID when untag change to tag and keep it by user manual).
11. First change TX Hold Multiplier to 2 then change TX Interval to 32767, then change TX Hold Multiplier to 3 and TX Interval to 120, we find the message "Invalid Message TX Hold Multiplier."
12. We suggest add "clear" button in LLDP Statistics Table.
13. The SIM Topology display error when we move device ICON, please see attach picture.

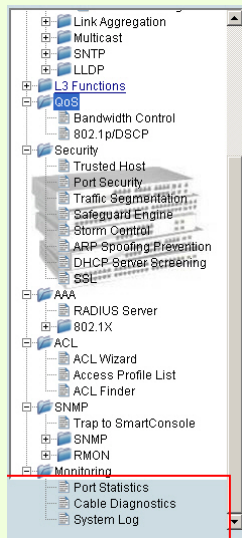
## 14. Web UI displays abnormally in Firefox 5.0 under Fedora 9

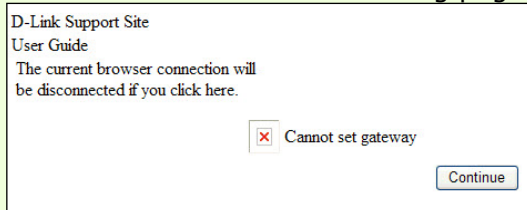
## 17. If apply DUT's IP address as the gateway in Smart Wizard, the web will redirect to the incorrect warning page.

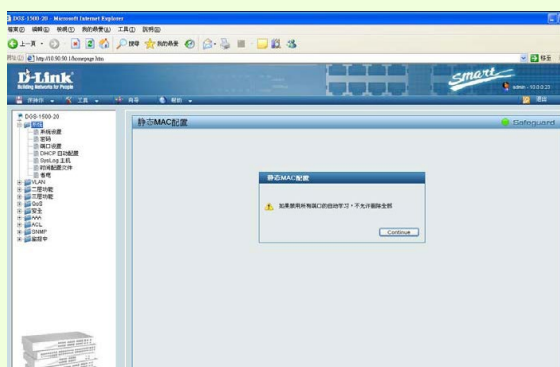
4. When we create two VLAN IP interfaces then set one of VLAN groups to ASV VLAN then join control PC MAC to ASV OUI, we find the control PC cannot ping (ARP not ICMP) to the DUT after join to ASV dynamic member a while. The DUT ARP Table display IP interface incorrect.
5. When we enable all ports of the DUT port-based Loopback Detection mode then change to VLAN-Based mode, we find the SFP interfaces of the DUT loopback detection function do not work.
6. We find SIM and 802.1X quick configurations page link error in all multi languages besides English.
7. After save config we find wrong page and message in Chinese.
