**Firmware Version:** 2.51.B007  
**Boot Code Version:** 1.00.015  
**MIB Version:** 2.50.002  
**D-View Module Version:** 1.0.0.7  
**Published:** Aug. 25, 2014

These release notes include important information about D-Link switch firmware revisions. Please verify that these release notes are correct for your switch:

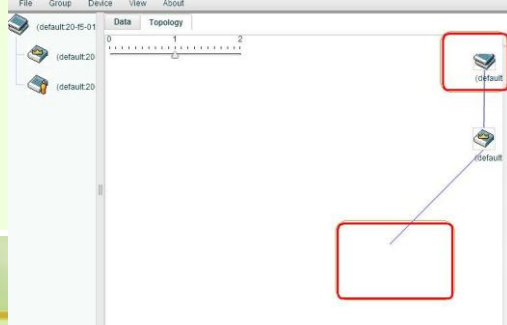
8. modify default System Time to 01/01/2011.
9. The drop-down fields of Time Profile 1 and 2 always show "None" instead of correct profile name when the profile name is more than 1 character.
10. First create VLAN2 then add port2 to Tag member and change PVID to 2 then add port3 to tag member, we find port2 PVID will change to 1. (We suggest don't change tag port PVID when untag change to tag and keep it by user manual).
11. First change TX Hold Multiplier to 2 then change TX Interval to 32767, then change TX Hold Multiplier to 3 and TX Interval to 120, we find the message "Invalid Message TX Hold Multiplier."
12. We suggest add "clear" button in LLDP Statistics Table.
13. The SIM Topology display error when we move device ICON, please see attach picture.

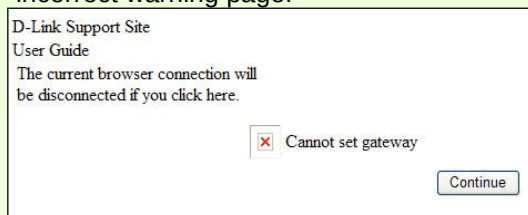
17. If apply DUT's IP address as the gateway in Smart Wizard, the web will redirect to the incorrect warning page.
