**Firmware Version:** 2.51.B022  
**Boot Code Version:** 1.00.017  
**MIB Version:** 2.50.002  
**D-View Module Version:** 1.0.0.7  
**Published:** April 09, 2018

| Firmware Version | Date | Model | Hardware Version |
|---|---|---|---|
| Runtime: v2.51.B022<br>Boot: 1.00.017 | 09-Apr.-18 | DGS-1500-28 | A2 |

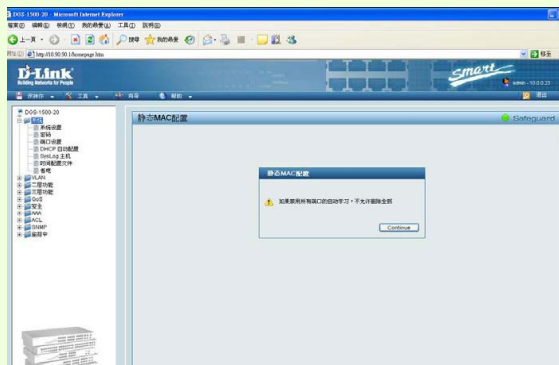
6. We find SIM and 802.1X quick configurations page link error in all multi languages besides English.
7. After save config we find wrong page and message in Chinese.

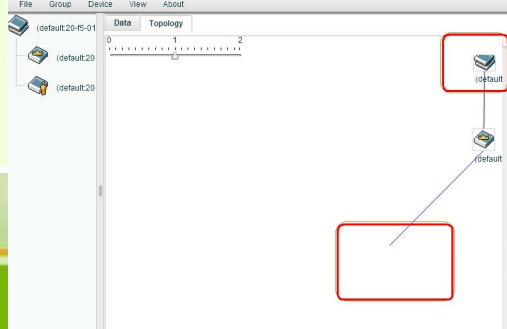
8. modify default System Time to 01/01/2011.
9. The drop-down fields of Time Profile 1 and 2 always show "None" instead of correct profile name when the profile name is more than 1 character.
10. First create VLAN2 then add port2 to Tag member and change PVID to 2 then add port3 to tag member, we find port2 PVID will change to 1. (We suggest don't change tag port PVID when untag change to tag and keep it by user manual).
11. First change TX Hold Multiplier to 2 then change TX Interval to 32767, then change TX Hold Multiplier to 3 and TX Interval to 120, we find the message "Invalid Message TX Hold Multiplier."
12. We suggest add "clear" button in LLDP Statistics Table.
13. The SIM Topology display error when we move device ICON, please see attach picture.

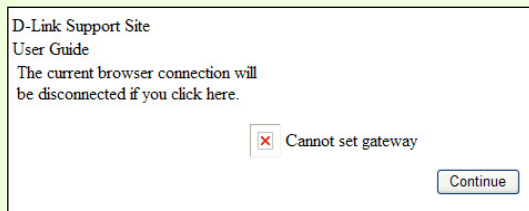
17. If apply DUT's IP address as the gateway in Smart Wizard, the web will redirect to the incorrect warning page.
