**Firmware Version:** 2.51.B022  
**Boot Code Version:** 1.00.017  
**MIB Version:** 2.51.001  
**D-View Module Version:** 1.0.0.7  
**Published:** Apr. 09, 2018

These release notes include important information about D-Link switch firmware revisions. Please verify that these release notes are correct for your switch:

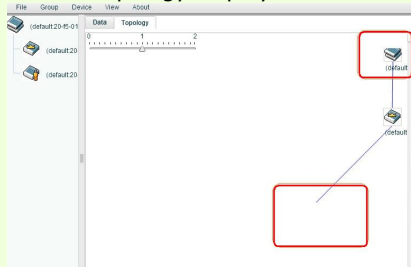
- 13.**The SIM Topology display error when we move device ICON, please see attach picture.

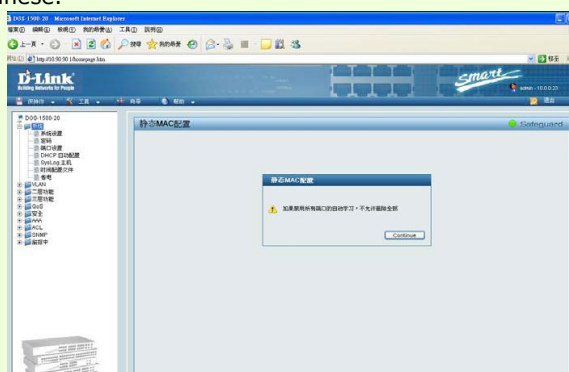
7. After save configure we find wrong page and message in Chinese.
