**Firmware Version:** 2.51.B007  
**Boot Code Version:** 1.00.015  
**MIB Version:** 2.50.002  
**D-View Module Version:** 1.0.0.7  
**Published:** Aug. 25, 2014

These release notes include important information about D-Link switch firmware revisions. Please verify that these release notes are correct for your switch:

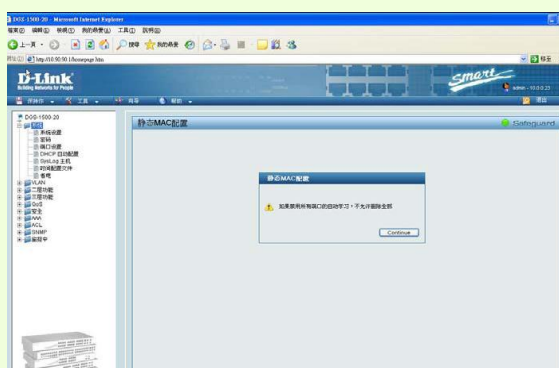
6. We find SIM and 802.1X quick configurations page link error in all multi languages besides English.
7. After save config we find wrong page and message in Chinese.
