**D-Link Systems, Inc.™**  
**xStack Storage DSN-3200 & DSN-3400**  
**ECN – Drive Activity Light Fix (rev. 1)**

This document is an ECN (Engineering Change Notice) concerning the identification of affected DSN-3200/3400 units shipped before January 2008 and the installation of four resistor packs to fix the issue.

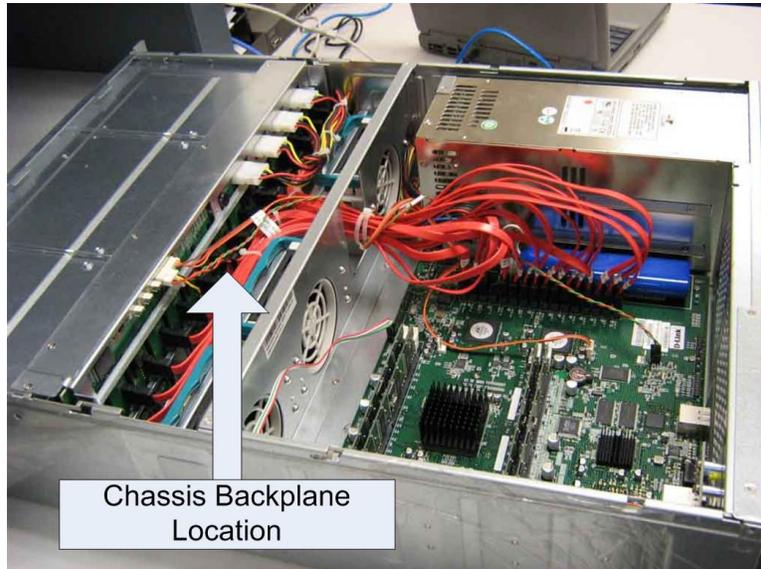
**Figure 3: Identifying the chassis backplane**

Step 5) Remove the top cover from the DSN-3200/3400. Located in the middle of the chassis is the chassis backplane as shown in figure 3.

Step 3) Please remove the cover from your DSN-3200/3400 to gain access to the chassis backplane PCB. The backplane is identified in figure 3.

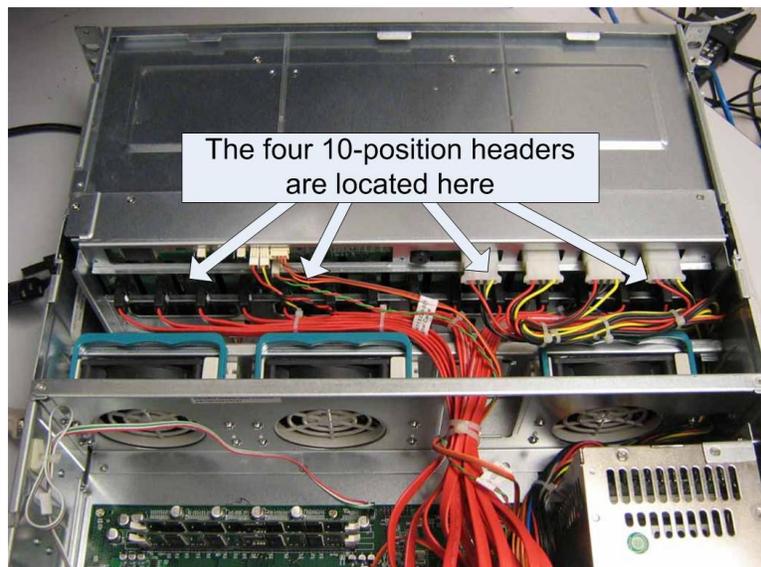
**Figure 4: Identifying the four 10-position headers**

Step 6) Located on the backplane are four 10-position headers labeled NA1315, NA0912, NA0508 and NA0104. The labels themselves are extremely small and difficult to read. Please see figure 4 to identify these headers. Note that the two right-most headers are made difficult to see because of the placement of four (4) four-position Molex power connectors. (In order to better orient you to the position of these jumpers, please see the bare backplane and identified headers shown in figure 5)

Step 4) Identify the four 10-position headers as shown in figures 4 & 5. The two right-most headers are blocked by the power connectors. Remove the two (2) Molex power connectors labeled CN4 and CN7 to gain easier access to the two (2) 10-position jumpers found below them. Please see figure 8 for details.

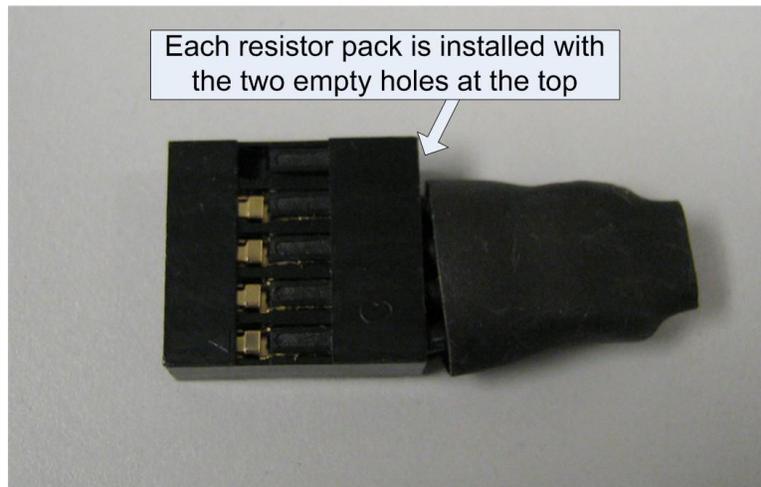
**Figure 10: The resistor pack: side view**

Step 7) Familiarize yourself with the resistor pack. Note that two of the positions are empty as seen in figure 10. Also be aware that one of the holes on the connector has been blocked as shown in figure 11. This blocked hole will need to match with the missing pin shown in figure 9.

Step 8) Carefully orient the resistor pack over the 10-position header, making sure the keyed hole matches the missing pin on the header. Press the resistor pack inwards until it is firmly seated. Figures 12 & 13 will give you a guide to what it will look like.
