**Firmware Version:** 1.00.015  
**Boot Code Version:** 1.00.010  
**MIB Version:** 1.00.008  
**D-View Module Version:** 1.0.0.7  
**Published:** Aug. 25, 2011

These release notes include important information about D-Link switch firmware revisions. Please verify that these release notes are correct for your switch:

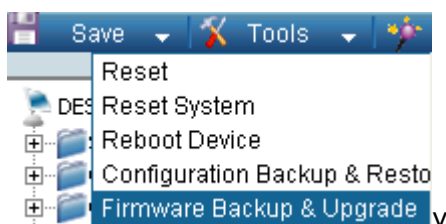
1. Connect a workstation installed with java SE runtime environment to any switch port of the device.
2. Open the web browser from the workstation and enter the IP address of the switch. The switch's default IP address is 10.90.90.90.
3. Enter administrator's password when prompted. The password is **admin** by default.
4. To update switch's firmware or configuration file, select **Tools > Firmware Backup & Upgrade** from the banner.

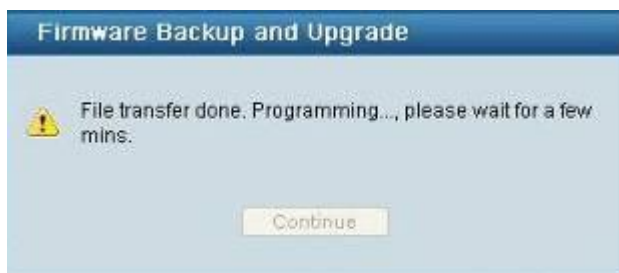
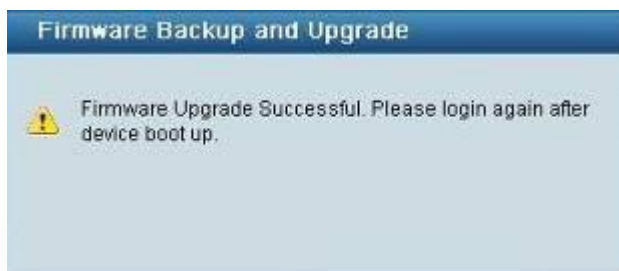
- e. Wait until the "Firmware Upgrade Successful" message pops up and login again after device boots up.

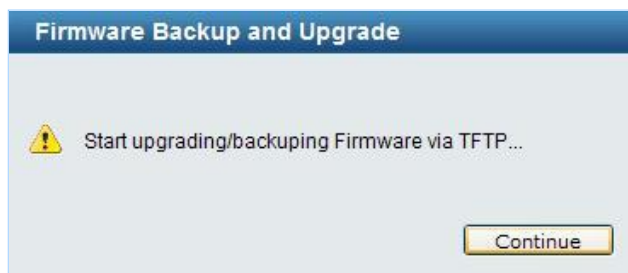
- d. Wait until the firmware upgrade ends and login again after device boots up.
