Firmware Version: 1.00.015
Boot Code Version: 1.00.010
MIB Version: 1.00.008
D-View Module Version: 1.0.0.7
Published: Aug. 25, 2011

These release notes include important information about D-Link switch firmware revisions. Please verify that these release notes are correct for your switch:

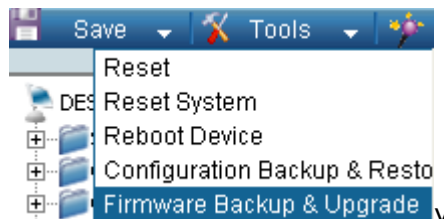
1. Connect a workstation installed with java SE runtime environment to any switch port of the device.
2. Open the web browser from the workstation and enter the IP address of the switch. The switch's default IP address is 10.90.90.90.
3. Enter administrator's password when prompted. The password is **admin** by default.
4. To update switch's firmware or configuration file, select **Tools > Firmware Backup & Upgrade** from the banner.

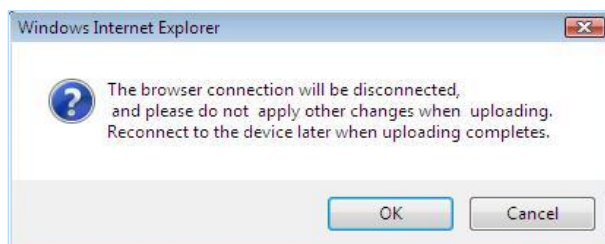
6. Select **HTTP** to upgrade the firmware to or from your local drive of PC.
 - a. Click **Browse** to browse your inventories for a saved firmware file
 - b. Click **Upgrade** after selecting the firmware file you want to restore
 - c. Click **OK** to continue with firmware upgrade

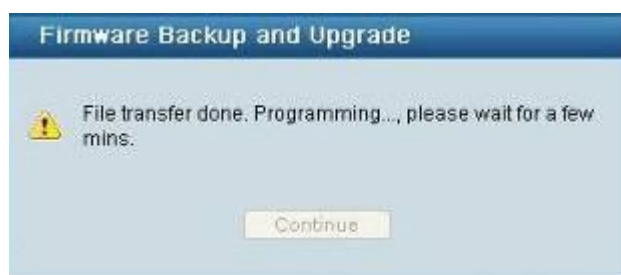
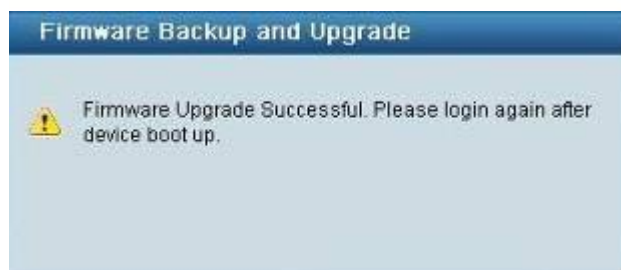
- e. Wait until the "Firmware Upgrade Successful" message pops up and login again after device boots up.

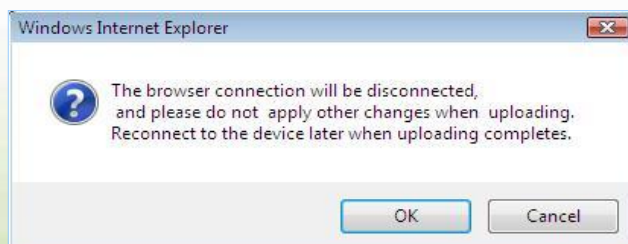
7. Select **TFTP** to upgrade the firmware to or from a remote TFTP server.
 - a. Enter the name of the firmware file located on the TFTP server
 - b. Click **Upgrade** after selecting the firmware file you want to restore
 - c. Click **OK** to continue with firmware upgrade

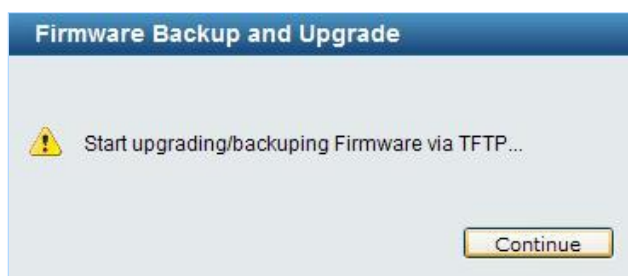
- d. Wait until the firmware upgrade ends and login again after device boots up.
