**Firmware Version:** 2.51.B007  
**Boot Code Version:** 1.00.013  
**MIB Version:** 2.50.002  
**D-View Module Version:** 1.0.0.7  
**Published:** Aug. 26, 2014

These release notes include important information about D-Link switch firmware revisions. Please verify that these release notes are correct for your switch:

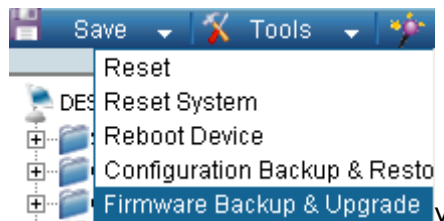
1. Connect a workstation installed with java SE runtime environment to any switch port of the device.
2. Open the web browser from the workstation and enter the IP address of the switch. The switch's default IP address is 10.90.90.90.
3. Enter administrator's password when prompted. The password is **admin** by default.
4. To update switch's firmware or configuration file, select **Tools > Firmware Backup & Upgrade** from the banner.

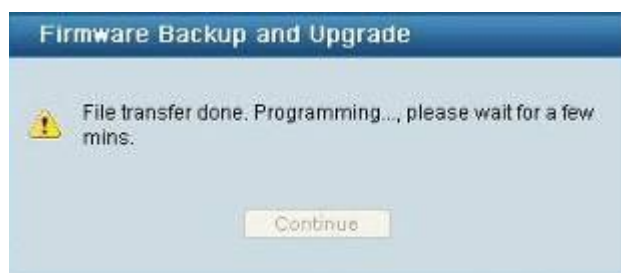
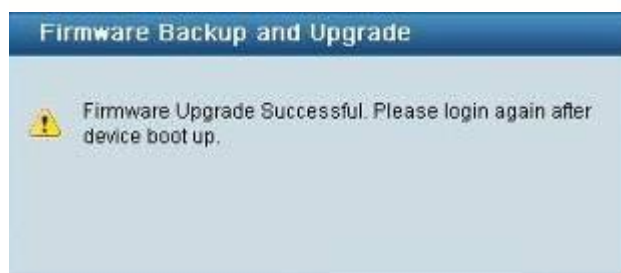
- e. Wait until the "Firmware Upgrade Successful" message pops up and login again after device boots up.

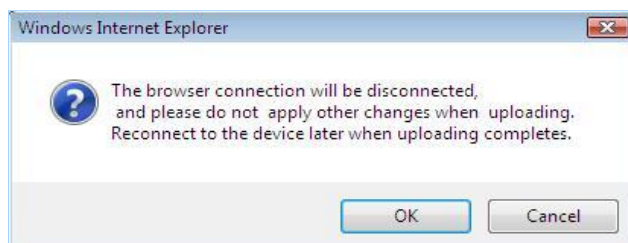
7. Select **TFTP** to upgrade the firmware to or from a remote TFTP server.
  - a. Enter the name of the firmware file located on the TFTP server
  - b. Click **Upgrade** after selecting the firmware file you want to restore
  - c. Click **OK** to continue with firmware upgrade
  - d.

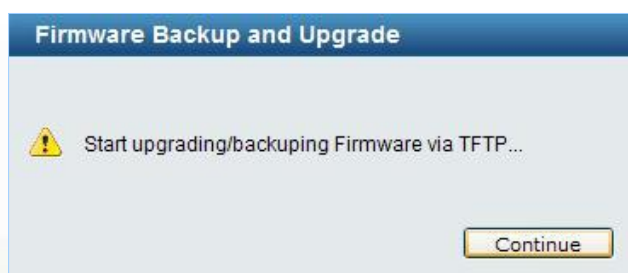
- e. Wait until the firmware upgrade ends and login again after device boots up.
