**Firmware Version:** 2.51.B022  
**Boot Code Version:** 1.00.017  
**MIB Version:** 2.50.002  
**D-View Module Version:** 1.0.0.7  
**Published:** Apr. 09, 2018

These release notes include important information about D-Link switch firmware revisions. Please verify that these release notes are correct for your switch:

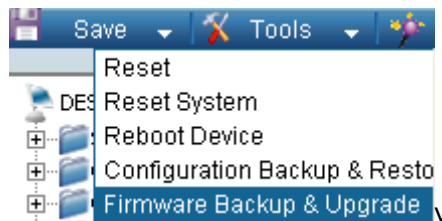
1. Connect a workstation installed with java SE runtime environment to any switch port of the device.
2. Open the web browser from the workstation and enter the IP address of the switch. The switch's default IP address is 10.90.90.90.
3. Enter administrator's password when prompted. The password is **admin** by default.
4. To update switch's firmware or configuration file, select **Tools > Firmware Backup & Upgrade** from the banner.

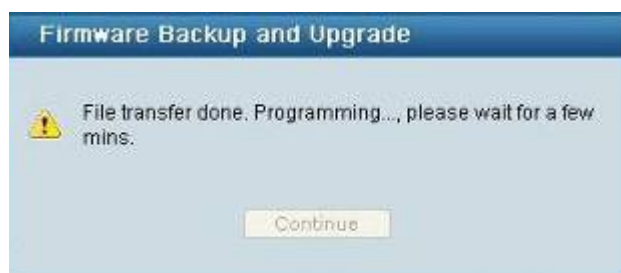
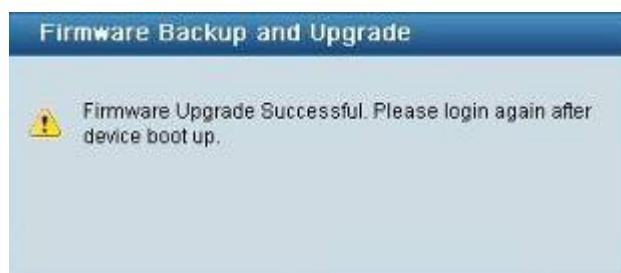
- e. Wait until the "Firmware Upgrade Successful" message pops up and login again after device boots up.

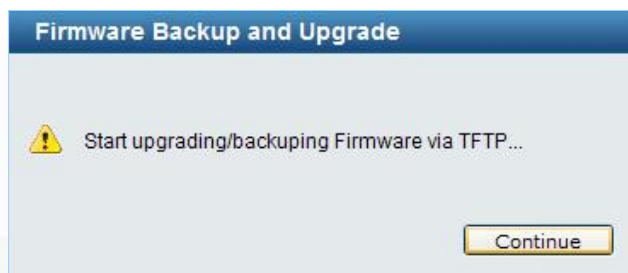
- e. Wait until the firmware upgrade ends and login again after device boots up.
